Section 2. PLANT SURVIVAL

This is the Year 1 Winter evaluation for the UT Hiwassee River stream relocation. A few of the crossvanes had water piping under them, however, the crossvanes were stable. The crossvanes should eventually silt up over time. Water was also piping under ground below the driveway culvert due to the blasting that took place during construction to relocate the stream. NCDOT will continue to monitor this stream relocation.

UT Hiwassee River

Year 1 Winter – February 2008

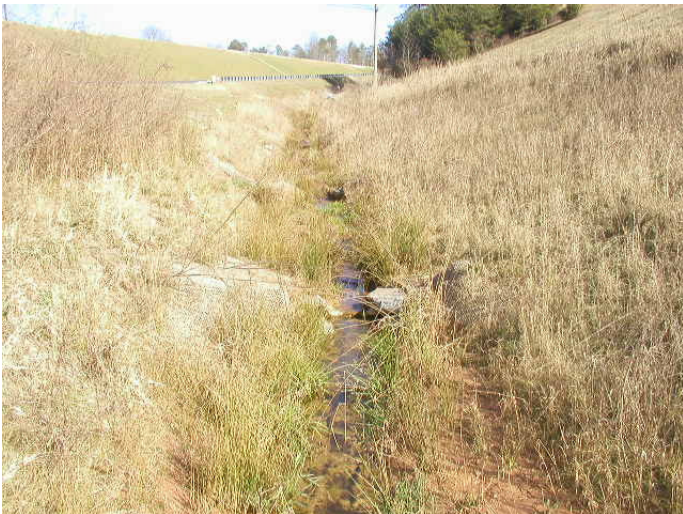
Photo Point #3 (Upstream)

Planted vegetation was minimal onsite. A portion of the streambank reforestation had been mowed as seen in photo point numbers 3 and 4.

Estimated causes, and proposed/required remedial action: Replanting will take place.
